# Metallographic Analysis of Brush Bristle and Integrity Testing of Brush Seal in Shroud Ring of T-700 Engine

Prepared for the  
Fifth International Symposium on Transport Phenomena and  
Dynamics of Rotating Machinery  
sponsored by the Pacific Center of Thermal Fluids Engineering  
Kaanapali, Maui, Hawaii, May 8-11, 1994

# **METALLOGRAPHIC ANALYSIS OF BRUSH BRISTLE AND INTEGRITY TESTING OF BRUSH SEAL IN SHROUD RING OF T-700 ENGINE**

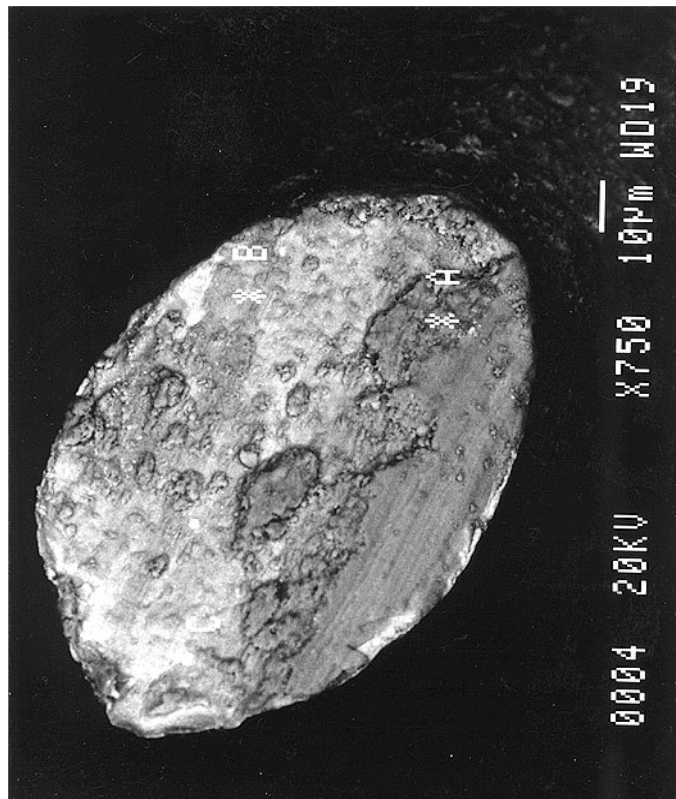
(a) Spectra locations A, B, and C.

(c) Spectra location B.

(d) Spectra location C.

Figure 12.—Tungsten variations over bristle tip.

With significant material transfer to the rotor and oxide scale formation over the bristle surface indicated by Figs. 9 and 10, an examination of a bristle tip (Fig. 11) showed wear traces, pitting, and material transfer. Figure 12 illustrates that although the base material appears as Haynes 25, the distribution of tungsten differs as noted in the element spectra. Therefore, some form of resolidification must have occurred right at the bristle-rub runner interface.

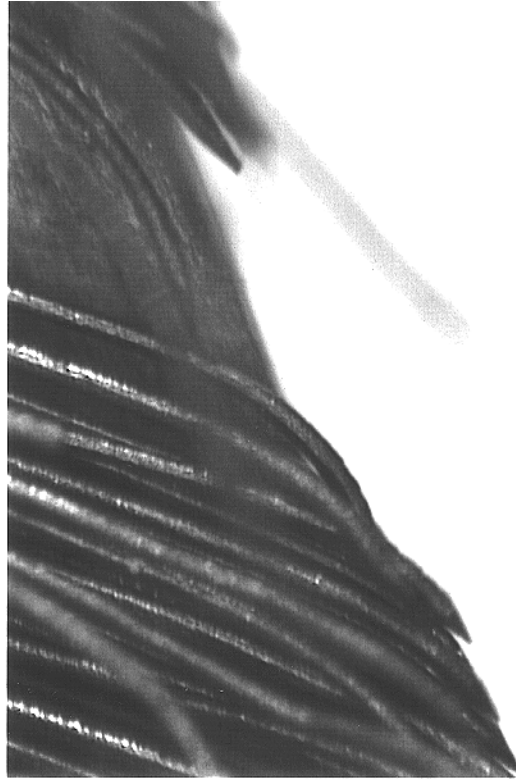
(a) Region void of bristles.

Figure 13.—Bristle geometry associated with installation, noted in post-test evaluation.

The post-test brush seal was examined by using a micro-video system. Several irregularities associated with installation were noted. One region was void of bristles; perhaps they were yanked out (Fig. 13(a)). Adjacent bristles were all bent over, on the leading edge but not in the core (Fig. 13(b)). One bristle of original length was kinked at the tip and appeared to be approximately 2.5 times as long as the remaining bristles (Fig. 13(c)). A closer look revealed some "snapped" bristles in that region, perhaps from forcing the brush into position or from catching bristles within the turbine blade gaps (Fig. 13(d)). The snapped

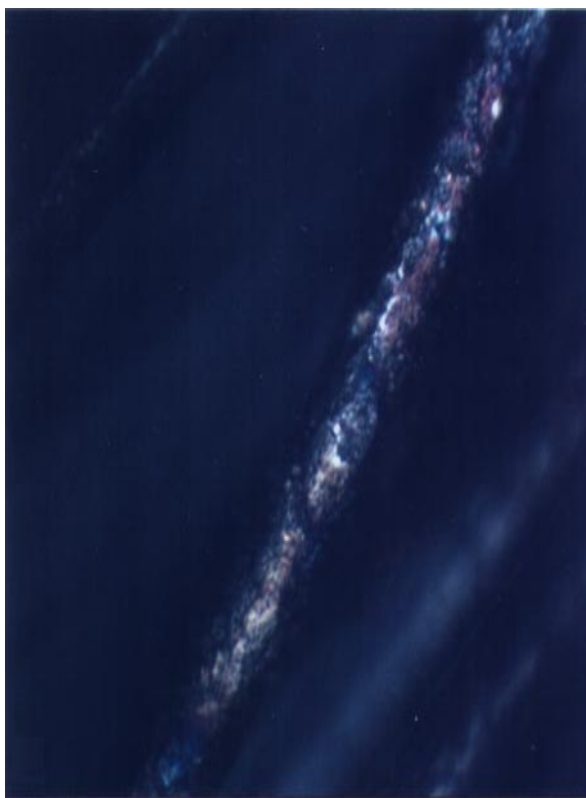
(g) Oxide scale on bristles.

bristles were very close to the pinch washer. Bristles near the pinch washer were broken or bent, but deeper into the brush bristle pack ( $N_x$ ) the bristles were straight and worn (Fig. 13(e)). The appearance of the first three rows  $N_x$  of the brush showed erratic rubbed wires, probably due to installation deformations. For  $N_x > 3$  the appearance was more uniform for the next nine rows. Higher magnification of the interface showed "smearing" of the bristle tips (Fig. 13(f)). Each bristle appeared to have some scale covering it, as evidenced from wire highlights and differential coloring, like air-quenched steel (Fig. 13(g)).
